Re: DEL-AIR LODGE REDEVELOPMENT
Substantial Performance

Date: **June 17th, 2024** JMAA Job # 1264-20 **Substantial Inspection**
Number of Pages (8)

Project: **Del Air Manning Redevelopment, Manning, Alberta**

MECHANICAL REVIEW

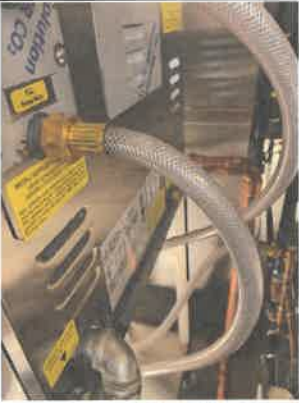
<p>3.3</p>	<p>Steamer in kitchen is fed with domestic water. The steamer will be generating steam and condensate at temperatures too high for the sanitary system to handle.</p> <p>Contractors to confirm the steamer has an integral “condensate cooler” to reduce the drain water waste temperature to below 140F. If there is no drain cooler, one will need to be added.</p>

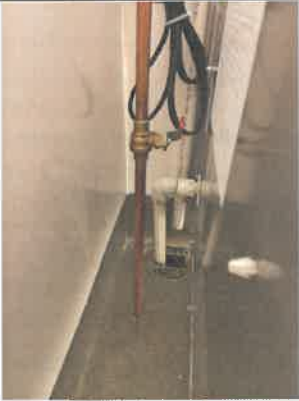
<p>Potential Deficient</p>
<p>3.4</p>	<p>Ice machine drain can be seen terminated directly into the floor drain. This drain line should have a minimum 1” air gap above the floor drain flood level rim.</p> <p>The 2nd drain in the background is the drain from the cooler evaporators. This drain will likely run regularly and is currently not terminated over the floor drain, which will result in puddling.</p> <p>The floor drain should have a Funnel installed so that both drains can terminate above and into the floor drain.</p>

<p>Deficient</p>

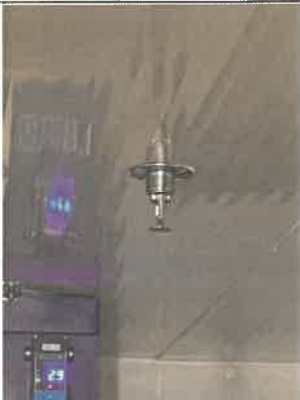
<p>3.5</p>	<p>Within the walk in coolers, the sprinkler heads are at low level and above shelving. It is recommended that sprinkler head protection in the form of a wire cage be installed anywhere that sprinkler heads are at risk of being hit.</p>

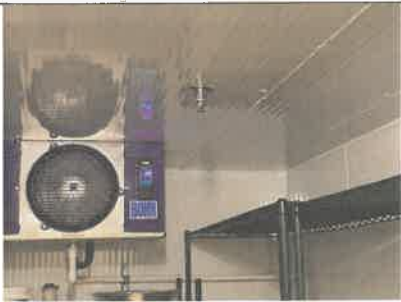
<p>Deficient</p>
<p>3.6</p>	<p>Within the walk in coolers, the sprinkler heads are at low level and above shelving. It is recommended that sprinkler head protection in the form of a wire cage be installed anywhere that sprinkler heads are at risk of being hit.</p>

<p>Deficient</p>

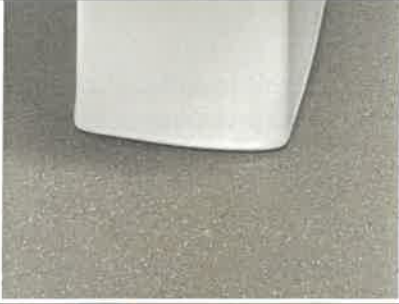
<p>3.7</p>	<p>Water closets are to be caulked at floor level.</p> <p>There is to be a gap in the caulking at the back of the bowl.</p>

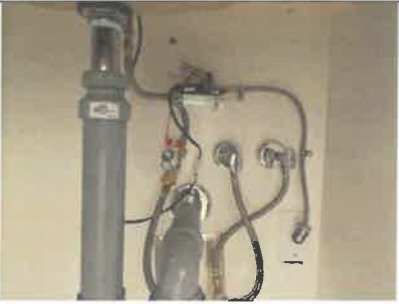
<p>Deficient</p>
<p>3.8</p>	<p>This photo shows a hands free lavatory faucet wiring assembly. Other assemblies to be checked.</p> <p>The control valve appears to be hung with the wiring, causing stress on the wiring assembly.</p> <p>The remaining 24v wiring is quite exposed to damage or water and should be within a enclosure of some type for protection and support.</p>

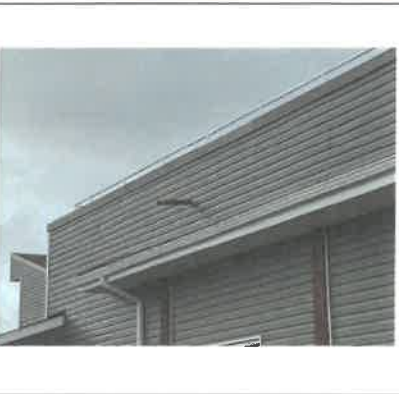
<p>Deficient</p>
<p>3.9</p>	<p>Scupper drain termination on the front exterior is unfinished.</p> <p>This is typical to several.</p> <p>There needs to be some form of seal between the pipe and siding to prevent weather from entering.</p> <p>The drain should be shortened and perhaps turned down?</p> <p>Is there any concern with roof shingle deterioration from the drain discharging from this height? This is a question for the roofing consultant to chime in on.</p>

<p>Deficient</p>

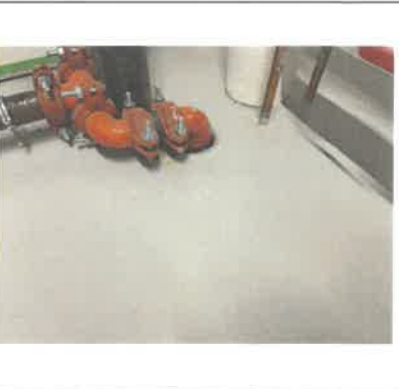
<p>3.10</p>	<p>In the water meter room.</p> <p>Floor drain "flange" is higher than the surrounding floor.</p> <p>The sprinkler drain has been installed into the drain preventing the drain from being used for any other purposes (such as a garden hose being used to drain other systems).</p> <p>Sprinkler drain can be raised to terminate above the drain, and it is preferred to have the drain cut at a 45 degree angle to encourage smooth flow.</p>

<p>Deficient</p>

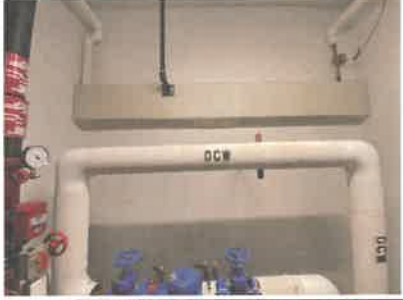
<p>3.11</p>	<p>Within the water meter room there are no gauges provided.</p> <p>It would be highly beneficial to be able to monitor the incoming water pressure.</p>

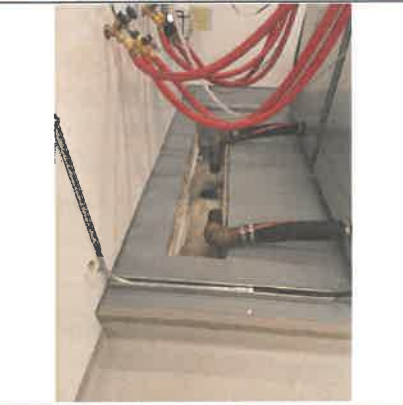
<p>Deficient</p>
<p>3.12</p>	<p>Washing machine drains are installed and were seen to operate when the machine was run.</p>

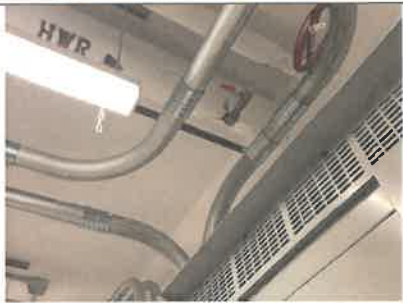
<p>Progress</p>
<p>3.13</p>	<p>In the electrical room, there are hot water supply and return valves not being used.</p> <p>These valves are to be plugged off to ensure there is no risk of water release over top of electrical equipment.</p>

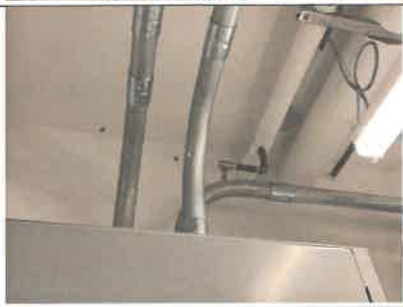
<p>Deficient</p>
<p>3.14</p>	<p>In the electrical room, there are hot water supply and return valves not being used.</p> <p>These valves are to be plugged off to ensure there is no risk of water release over top of electrical equipment.</p>

<p>Deficient</p>

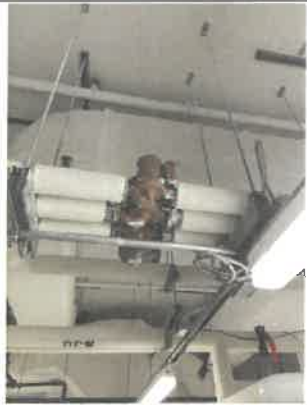
<p>3.15</p>	<p>In the mechanical room, the recirc pumps for the 3 zones have been installed but are missing the check valves as shown on drawing M7.1 detail 2.</p> <p>Pumps P-4 & P-5 are to have temperature gauges installed on these lines to help confirm flow and temperatures of the separate water temperature loops.</p> <p>Pump P-3 is to circulate between the storage tanks and hot water tanks and does not show a temperature gauge, however, it would be nice to have one there as well.</p>

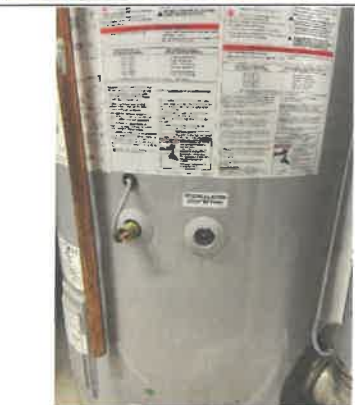
<p>Deficient</p>
<p>3.16</p>	<p>The recirc lines shown in the photo above are to be terminated into the hot water tanks, utilizing the dedicated return connection as noted on the tank itself.</p> <p>The drawings provided on M7.1 detail 2 do not show this specifically, however the drawings are diagrammatic and do not show specific manufacturers details.</p> <p>Contractors to refer to installation instructions provided with the hot water tanks to connect the piping as recommended.</p>

<p>Deficient</p>

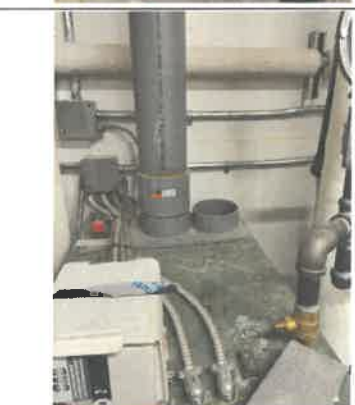
<p>3.17</p>	<p>Hot water boilers as well as steam humidifier have all been left with the combustion air connection wide open and exposed.</p> <p>It is best practice to install a piece of pipe and an elbow to at least get the opening vertical to reduce the amount of airborne and settling debris that falls into the units.</p> <p>The drawings do call for the combustion air to be drawn from the space, but some additional piping is required.</p>

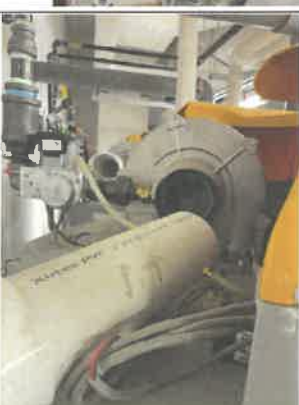
<p>Deficient</p>
<p>3.18</p>	<p>On the hot water tanks (2) both of the combustion air connections have been removed from the fan assembly?</p> <p>This short piece of pipe has a bird screen as well as the 2 vacuum tube connections tapped into it that connect to the fan and gas train assembly. These tubes provide operating information to the hot water tank and MUST be installed for the tanks to operate correctly.</p> <p>Contractors to consult the manufacturers instructions for specific requirements.</p>

<p>Deficient</p>

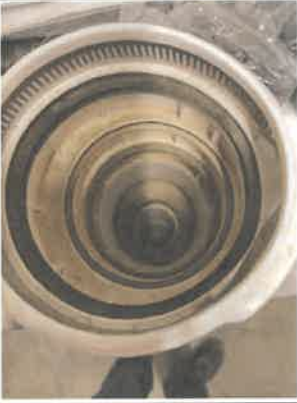
<p>3.19</p>	<p>This is a photo of the air intake (combustion air) of the steam humidifier. Although the debris is coming from the mechanical room, a lot of the debris / dirt you see is just settling in due to the vertically open connection.</p>

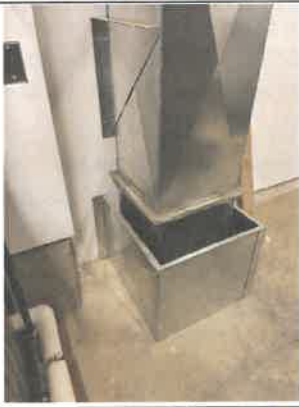
<p>Deficient</p>
<p>3.20</p>	<p>Contractors to confirm that the "free area" of the combustion air intake shown here is maintained.</p> <p>Drawing M5.2 detail 1 calls for the CA duct to be 400 x 400. The "free area around the duct must be equal to or greater than the duct opening itself. The space measured from the duct to the floor mounted metal baffle.</p> <p>With the baffle being 3 sided, there is a concern that the free area is not sufficient.</p>

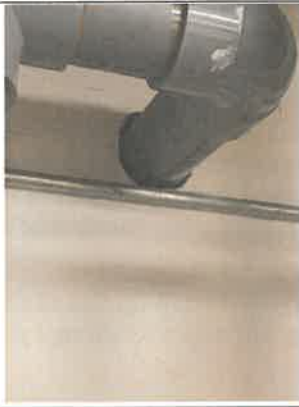
<p>Deficient</p>
<p>3.21</p>	<p>All combustion exhaust piping from the 5 gas appliances are terminated out the sidewall. All have been left with an unsealed gap around the piping. Daylight can be seen and therefore this must be sealed up both inside and outside c/w vapour barrier being considered.</p>

<p>Deficient</p>

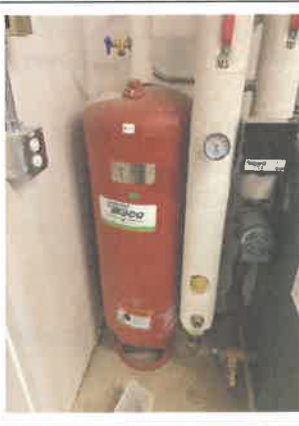
<p>3.22</p>	<p>All expansion tank bladder pressures to be confirmed by the contractor as compared to the operating pressure of the related system. Proper air pressure method is:</p> <ul style="list-style-type: none"> - System operation pressure to be confirmed. - Expansion tank isolated from system and drained. - Air pressure to be equal to operating pressure of system. - System opened back up to Expansion tank, preferably at ambient temperature. - Tank air pressure to be permanently recorded for reference. - Air pressure CANNOT be adjusted or measured while the tank is connected to the system.

<p>Possible deficient</p>

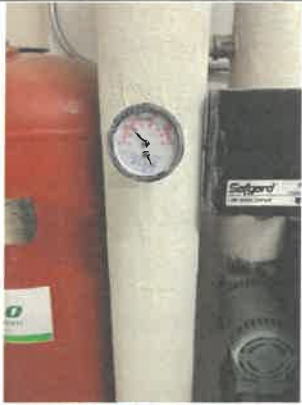
<p>3.23</p>	<p>The gauge shown here is on the heating system. If during heating season the pressure of this gauge goes up and down, then the expansion tank has not been properly charged.</p>

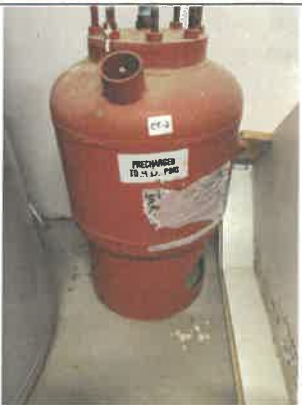
<p>Info</p>
<p>3.24</p>	<p>This tank is on the domestic water system. There is no gauge that I could find to confirm the domestic water pressure.</p> <p>The tank has a "precharged" 40psi label on it, which is unclear if this was shipped at this pressure (to keep the bladder shape) or if it has been charged as per the above instructions.</p>

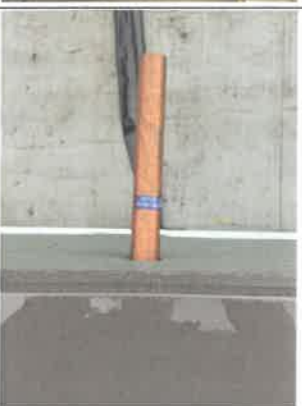
<p>Info</p>
<p>3.25</p>	<p>This is another termination of a scupper drain from the roof projecting out the side of the parapet. The pipe has not been sealed to the exterior.</p> <p>The length of the pipe is in question. As is the termination directly over an outdoor patio.</p>

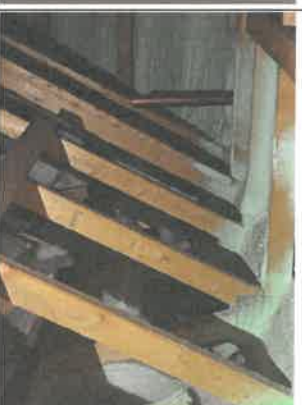
<p>Deficient</p>
<p>3.26</p>	<p>This is another scupper drain that has been brought into the attic space and left open in the attic.</p> <p>Not sure where this drain is meant to be piped, but it cannot be left as it is here.</p>

<p>Deficient</p>

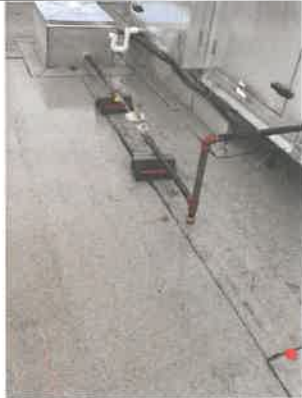
<p>3.27</p>	<p>Another scupper drain that I do not have a photo of, has been tied into a plumbing vent. This is NOT acceptable. In the event of water draining from the roof and down the vent it could negatively impact the plumbing vents performance.</p> <p>All scuppers should be terminated to the exterior OR, if possible, terminated into the RWL to the interior of the building.</p> <p>Using the RWL would be acceptable as the risk of roof drain blockage is at the roof drain, and therefore connecting downstream of the roof drain would be acceptable.</p>	<p>NO PHOTO</p>	<p>Deficient</p>
<p>3.28</p>	<p>Gas line on roof serving roof top unit is to be cleaned and painted yellow.</p>

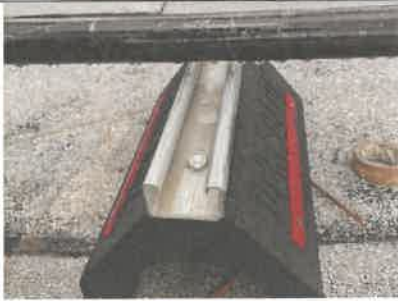
<p>Deficient</p>
<p>3.29</p>	<p>Gas line to RTU is to be reworked so as to sit on the gas pipe support provided. Gas pipe should be secured to the roof top block and no pressure should be transferred to the unit connection (currently the gas pipe is hanging from the unit).</p>

<p>Deficient</p>

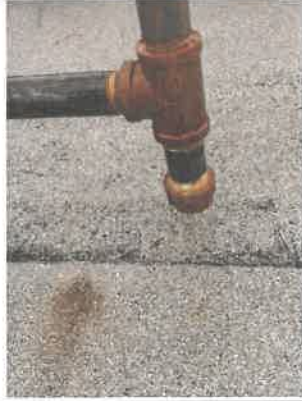
<p>3.30</p>	<p>New gas code requirements call for drip pockets to NOT be used in roof top applications.</p> <p>There is a risk of moisture being collected in the drip pocket, freezing in the winter and splitting the cap or piping.</p>

<p>Deficient</p>

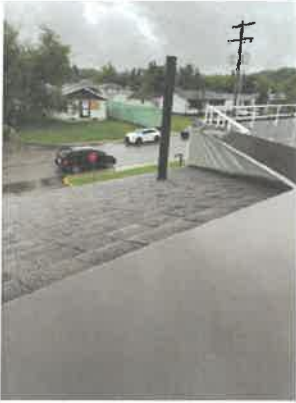
3.31	<p>Plumbing vent termination height is excessive. Piping to be cut down to a reasonable level while still ensuring it is clear of snow loading.</p>

<p>Deficient</p>
